A COMMONLY HELD MISCONCEPTION IS THAT STAINLESS STEEL WILL NOT SHOW SIGNS OF CORROSION.

THE SCIENCE BEHIND THE STAINLESS.

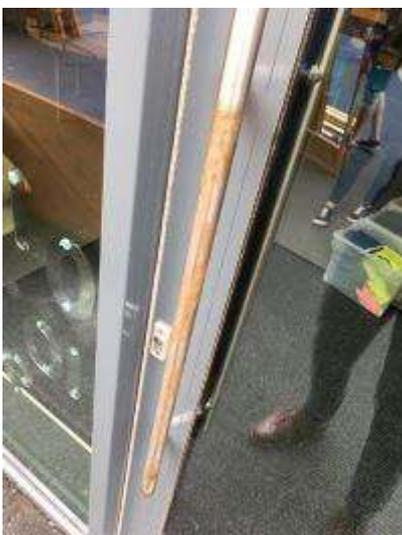
1. The first and most common causes of 'flash rust', 'tea staining' or 'rouging' as it is commonly known are **industrial cleaners** that contain a **chloride ingredient**. During cleaning of a building these cleaners work well on most surfaces but if applied to stainless steel they will contaminate the oxide layer of the stainless and within a short time, typically a few days, an appearance of a rouge bloom will form, some of which can be quite alarming, see below:

Generally brushed stainless finishes are completed in the polishing shop with a 240-grit scotch bright cloth. This is wiped around the product by hand to ensure a smooth consistent appearance. To rectify the issue of flash rust we recommend that the same process is repeated on site whilst the door handles are in situ. Carefully wipe around the area, with the grain of the brush marks and the stain is removed completely.

Following this, wipe down with a solution of soap and water.

The passive oxide layer will then repair itself once it has contact with non-contaminated air and the issue should not arise again.

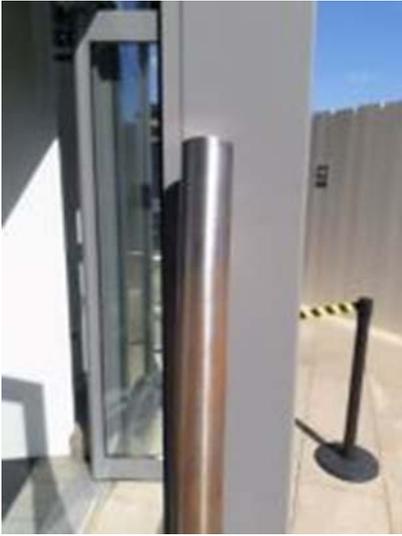
2. The second most common cause is that of **airborne carbon steel** particles that are carried onto the surface of the oxide layer and when combined with moisture the particles dissolve to form iron oxide which will appear as localised flash rust spots. In a marine environment, **seawater droplets** will evaporate and increase the salt and chloride concentration around the oxide layer, again causing stain.
