A COMMONLY HELD MISCONCEPTION IS THAT STAINLESS STEEL WILL NOT SHOW SIGNS OF CORROSION

THE SCIENCE BEHIND THE STAINLESS

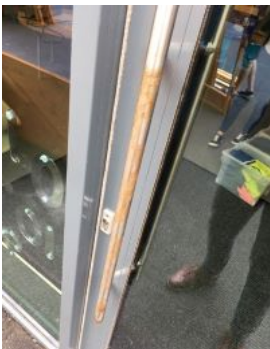
1. The first and most common causes of 'flash rust', 'tea staining' or 'rouging' as it is commonly known are industrial cleaners that contain a chloride ingredient. During cleaning of a building these cleaners work well on most surfaces but if applied to stainless steel they will contaminate the oxide layer of the stainless and within a short time, typically a few days, an appearance of a rouge bloom will form, some of which can be quite alarming, see below:

Generally brushed stainless finishes are completed in the polishing shop with a 240-grit scotch bright cloth. This is wiped around the product by hand to ensure a smooth consistent appearance. To rectify the issue of flash rust we recommend that the same process is repeated on site whilst the door handles are in situ. Carefully wipe around the area, with the grain of the brush marks and the stain is removed completely.

Following this, wipe down with a solution of soap and water.

The passive oxide layer will then repair itself once it has contact with non-contaminated air and the issue should not arise again.

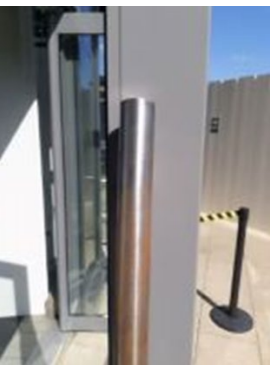
2. The second most common cause is that of **airborne carbon steel** particles that are carried onto the surface of the oxide layer and when combined with moisture the particles dissolve to form iron oxide which will appear as localised flash rust spots. In a marine environment, **seawater droplets** will evaporate and increase the salt and chloride concentration around the oxide layer, again causing stain.

3. The third most common cause is general dirt and grinding dust which is generated from cutting of tiles or brickwork in the locality. Again, this is airborne and will lie on the surface and in the case of brushed finishes, will lie in the grain and contaminate the oxide layer, and eventually a reddish area will appear.
